PAVEMENT SURFACE EVALUATION AND RATING (PASER) STUDY

SOPRIS VILLAGE WATER AND IRRIGATION SYSTEM

December 2021

SGM Project # 2016-133.002

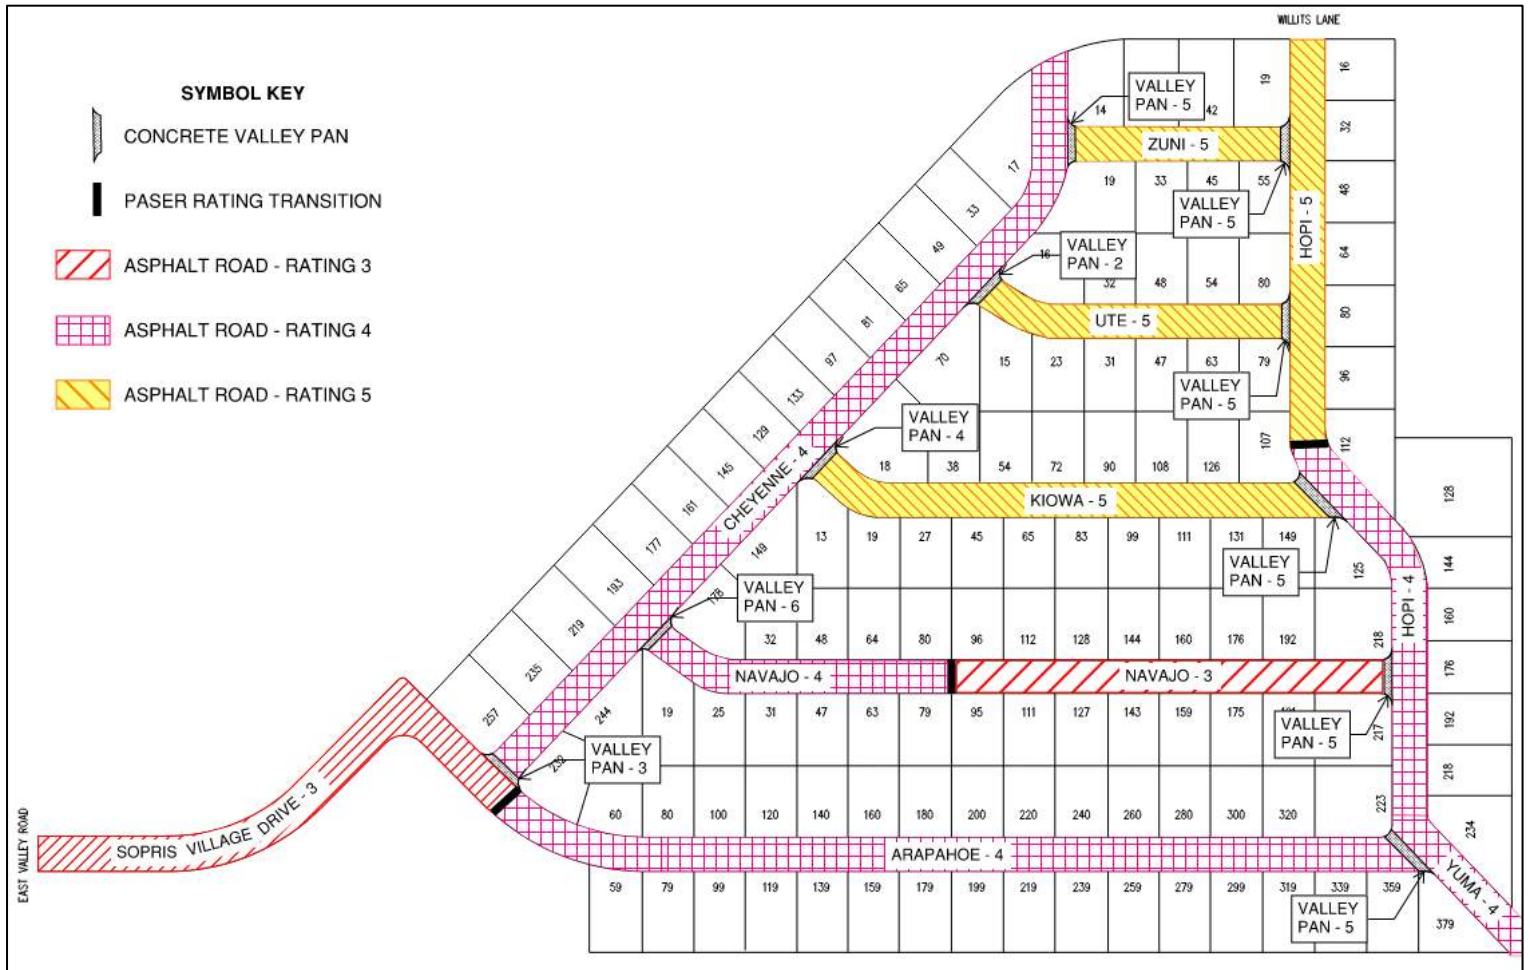
Figure 3-1. PASER Ratings for Asphalt and Concrete Within Sopris Village HOA

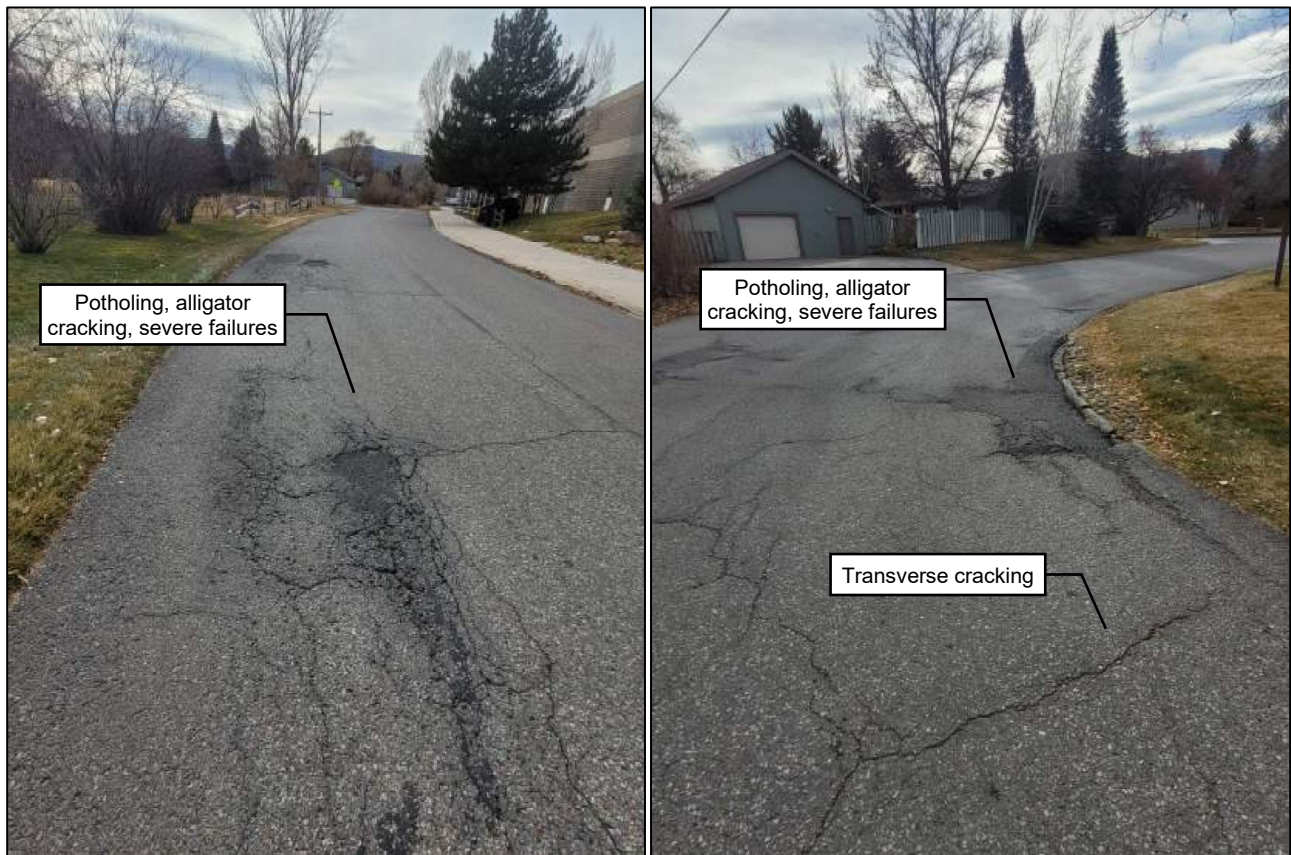
STREET SECTION DESCRIPTION	ASPHALT PASER RATING	MINIMUM RECOMMENDED REMEDY/ ACTION	NOTES
Sopris Village Drive	3	Structural overlay > 2", patching and repair prior to a major overlay, milling would extend overlay life	<ul style="list-style-type: none"> • Severe cracking and blocking, 5' to 10' • Ruts are 1/2" deep • Potholes are present and old repairs are failing • Alligator cracking extensive

Figure 3-2. Sopris Village Drive Roadway Conditions

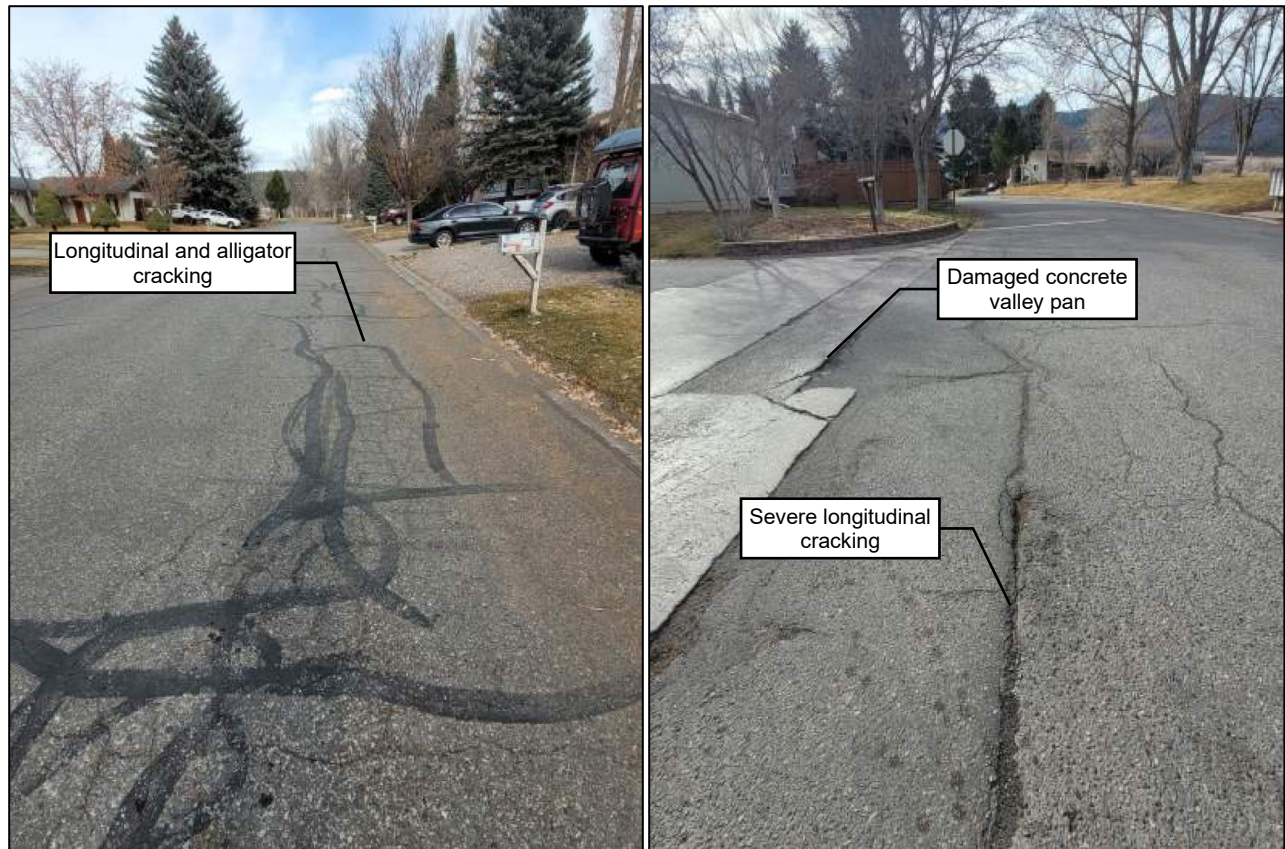
STREET SECTION DESCRIPTION	ASPHALT PASER RATING	MINIMUM RECOMMENDED REMEDY/ ACTION	NOTES
Arapahoe	4	Structural overlay > 2"	<ul style="list-style-type: none"> • Longitudinal cracking present but not continuous • 10' to 20' blocking • Alligator cracking in areas (5) • Severe unraveling in area • Cracks ½" to 1" some previously sealed

VALLEY PAN LOCATION	CONCRETE PASER RATING	MINIMUM RECOMMENDED REMEDY/ ACTION	NOTES
Intersection of Arapahoe and Yuma	5	Grind and repair surface defects. Some partial depth joint repairs or patching may be needed.	<ul style="list-style-type: none"> • Spalling • Moderate Cracking • Alligator cracking in areas (5) • Severe unraveling in area • Cracks ½" to 1" some previously sealed

Figure 3-3. Arapahoe Roadway Conditions

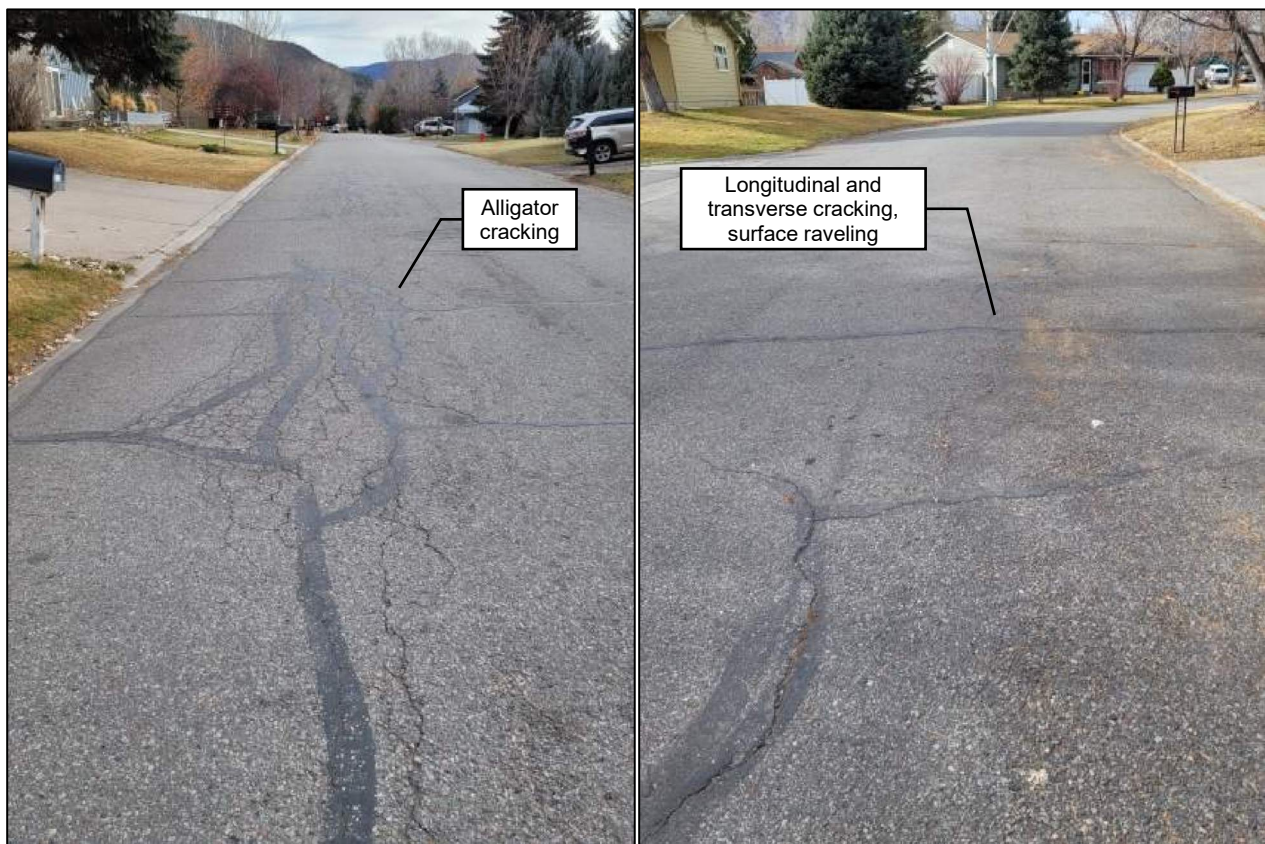
STREET SECTION DESCRIPTION	ASPHALT PASER RATING	MINIMUM RECOMMENDED REMEDY/ ACTION	NOTES
Cheyenne	4	Structural overlay > 2"	<ul style="list-style-type: none"> • Longitudinal cracking common • 5' to 10' blocking • Extensive areas with alligator cracking • Unraveling areas severe • Moderate polishing • Cracks ½" to 1" some have been previously sealed

VALLEY PAN LOCATION	CONCRETE PASER RATING	MINIMUM RECOMMENDED REMEDY/ ACTION	NOTES
Intersection of Cheyenne and Arapahoe	3	Extensive full depth repairs or full replacement.	<ul style="list-style-type: none"> • Valley pan cracked • Multiple pieces of concrete missing

Figure 3-4. Cheyenne Roadway Conditions

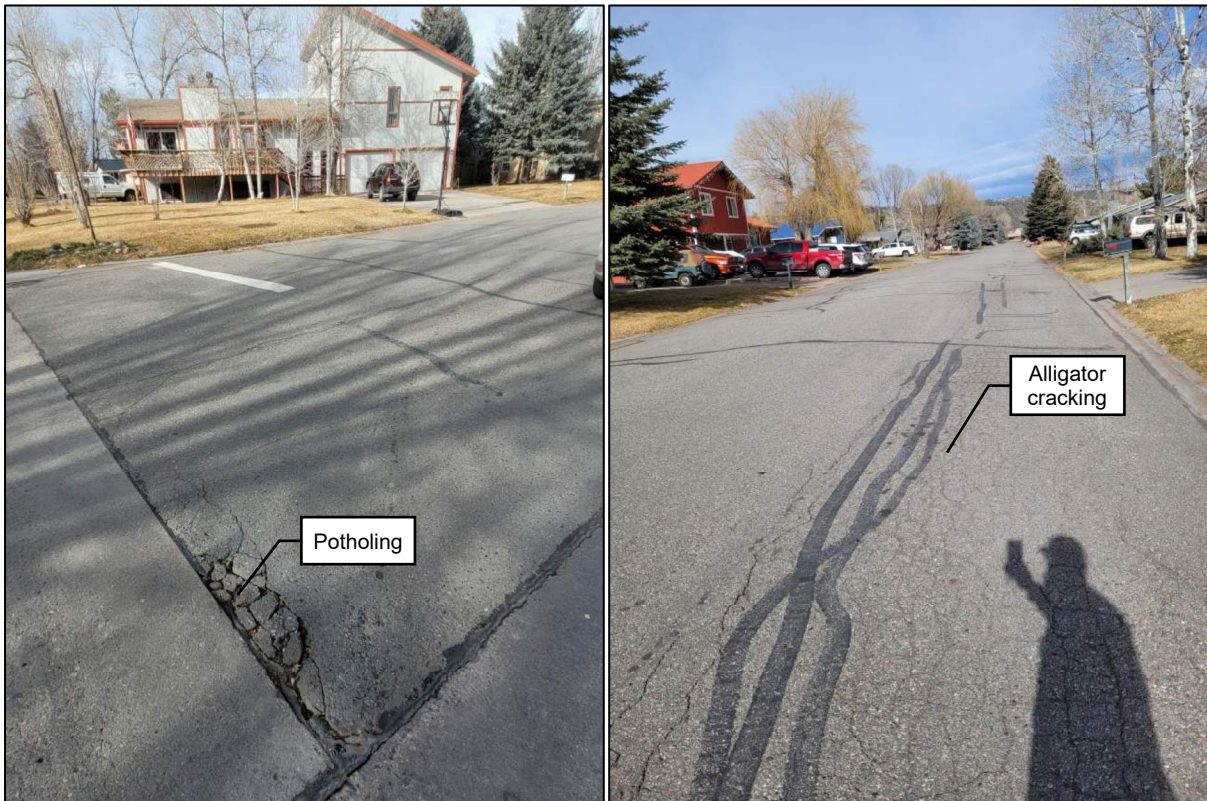
STREET SECTION DESCRIPTION	ASPHALT PASER RATING	MINIMUM RECOMMENDED REMEDY/ ACTION	NOTES
19 Navajo to 79 Navajo	4	Structural overlay > 2"	<ul style="list-style-type: none"> • Longitudinal cracking common • 5' to 10' blocking • Extensive areas with alligator cracking • Unraveling areas severe • Moderate polishing • Cracks ½" to 1" some have been previously sealed
95 Navajo to 217 Hopi	3	Structural overlay > 2", patching and repair prior to a major overlay, milling would extend overlay life

VALLEY PAN LOCATION	CONCRETE PASER RATING	MINIMUM RECOMMENDED REMEDY/ ACTION	NOTES
Intersection of Navajo and Cheyenne	6	Seal open joints and cracks. Overlay surface raveling areas.	<ul style="list-style-type: none"> • Moderate cracking
Intersection of Navajo and Hopi	5	Grind and repair surface defects. Some partial depth joint repairs or patching may be needed.	<ul style="list-style-type: none"> • Moderate cracking

Figure 3-5. Navajo Roadway Conditions

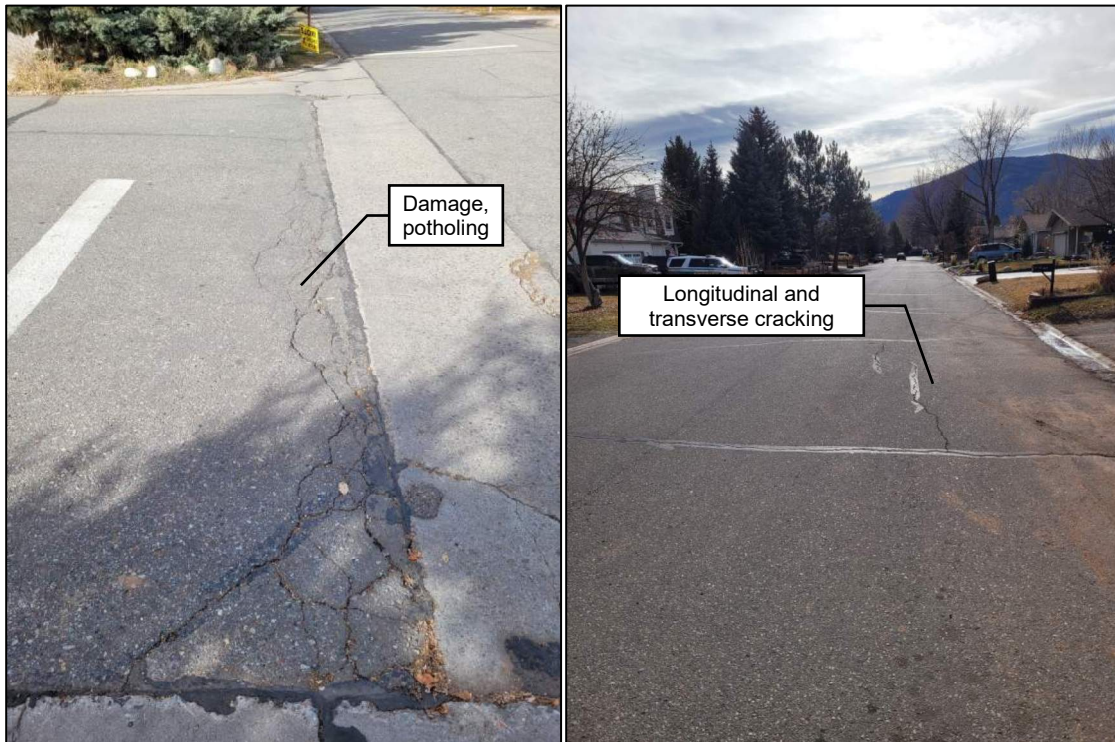
STREET SECTION DESCRIPTION	ASPHALT PASER RATING	MINIMUM RECOMMENDED REMEDY/ ACTION	NOTES
Kiowa	5	Maintain with sealcoat or thin overlay	<ul style="list-style-type: none"> • Blocking 10' to 20' • Moderate unraveling • Little to no alligator cracking • Little to no longitudinal cracking • Asphalt heaved in one area which appears to be the result of adjacent tree roots • Cracks are ½" to 1" some previously sealed

VALLEY PAN LOCATION	CONCRETE PASER RATING	MINIMUM RECOMMENDED REMEDY/ ACTION	NOTES
Intersection of Kiowa and Cheyenne	4	Some full depth repairs, surface texturing.	<ul style="list-style-type: none"> • Moderate cracking
Intersection of Kiowa and Hopi	5	Grind and repair surface defects. Some partial depth joint repairs or patching may be needed.	<ul style="list-style-type: none"> • Small to moderate cracking

Figure 3-6. Kiowa Roadway Conditions

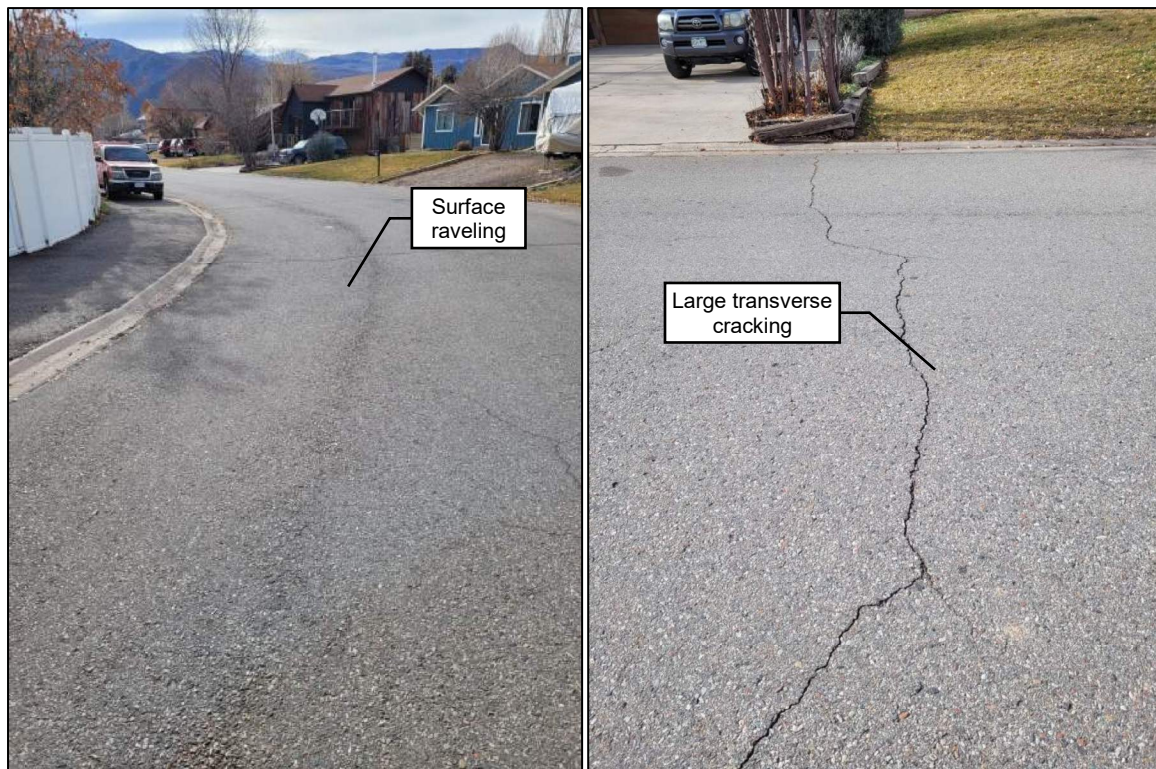
STREET SECTION DESCRIPTION	ASPHALT PASER RATING	MINIMUM RECOMMENDED REMEDY/ ACTION	NOTES
Ute	5	Maintain with sealcoat or thin overlay	<ul style="list-style-type: none"> • Blocking 20' to 40' • Little to no unraveling • Cross cracking 20' to 40' with very few longitudinal cracking • Asphalt heaved in one area which appears to be the result of adjacent tree roots • Cracks are 1/2" to 1" some previously sealed

VALLEY PAN LOCATION	CONCRETE PASER RATING	MINIMUM RECOMMENDED REMEDY/ ACTION	NOTES
Intersection of Ute and Cheyenne	2	Replace	<ul style="list-style-type: none"> • Badly broken • Multiple cracks
Intersection of Ute and Hopi	5	Grind and repair surface defects. Some partial depth joint repairs or patching may be needed.	<ul style="list-style-type: none"> • Small to moderate cracking

Figure 3-7. Ute Roadway Conditions

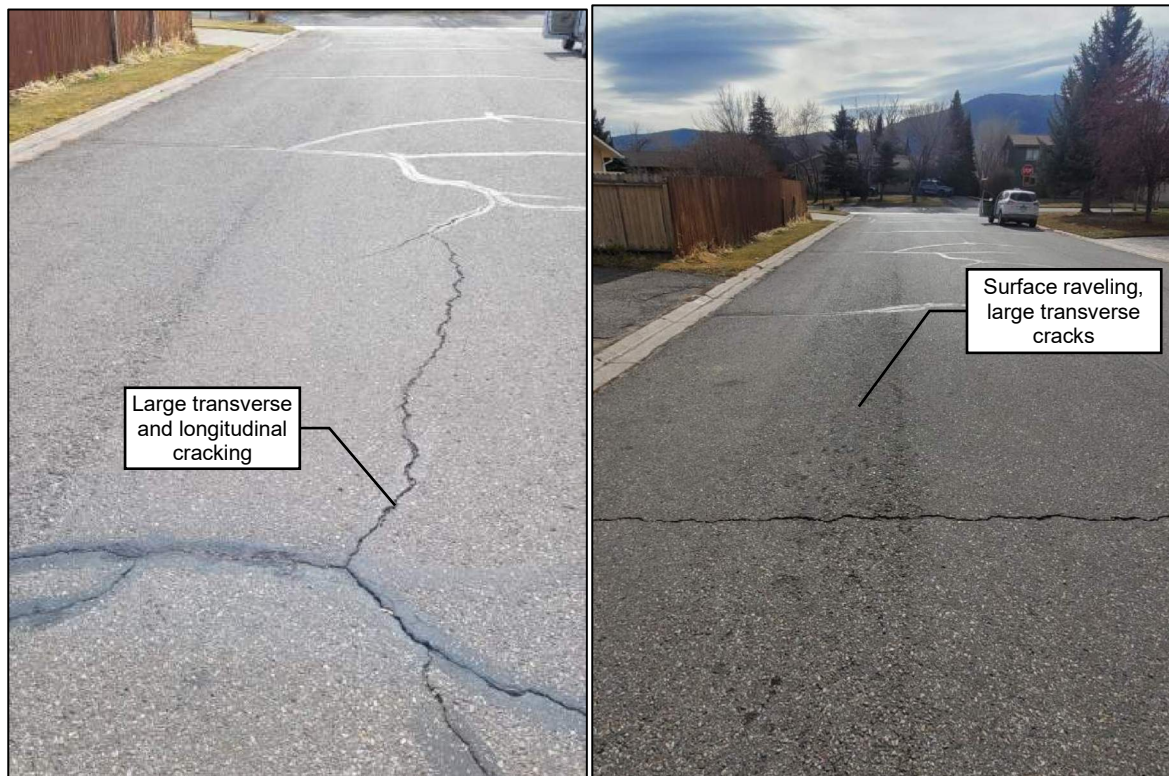
STREET SECTION DESCRIPTION	ASPHALT PASER RATING	MINIMUM RECOMMENDED REMEDY/ ACTION	NOTES
Zuni	5	Maintain with sealcoat or thin overlay	<ul style="list-style-type: none"> • Transverse cracks 10' to 50' • Little to no longitudinal cracking • Unraveling moderate in isolated areas • Cracks are ½" to 1" some previously sealed

VALLEY PAN LOCATION	CONCRETE PASER RATING	MINIMUM RECOMMENDED REMEDY/ ACTION	NOTES
Intersection of Zuni and Cheyenne	5	Grind and repair surface defects. Some partial depth joint repairs or patching may be needed.	<ul style="list-style-type: none"> • Some spalling • Small to moderate cracking
Intersection of Zuni and Hopi	5	Grind and repair surface defects. Some partial depth joint repairs or patching may be needed.	<ul style="list-style-type: none"> • Some spalling • Small to moderate cracking

Figure 3-8. Zuni Roadway Conditions

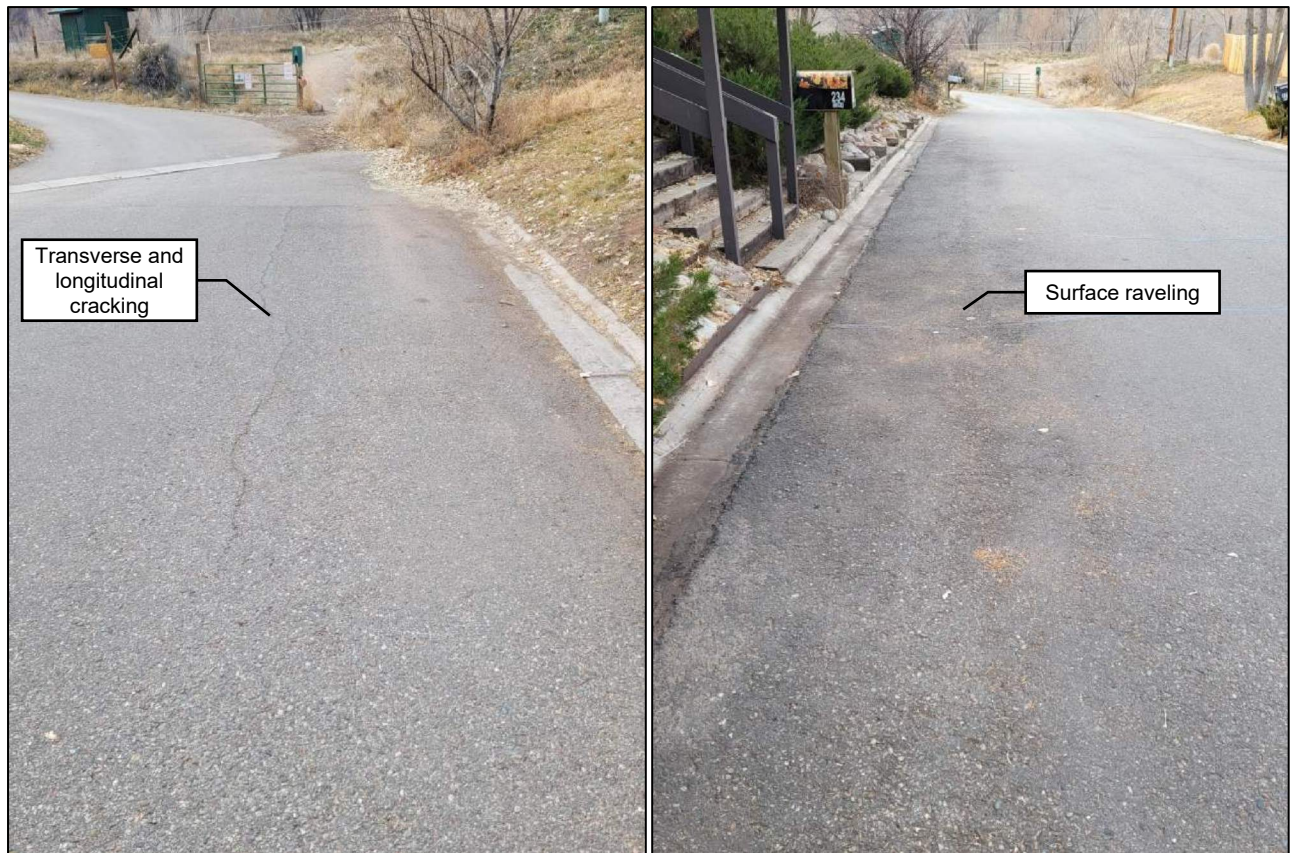
STREET SECTION DESCRIPTION	ASPHALT PASER RATING	MINIMUM RECOMMENDED REMEDY/ ACTION	NOTES
Yuma	4	Structural overlay > 2"	<ul style="list-style-type: none"> • Blocking 5' to 10' • Longitudinal cracking common • Unraveling in areas • Some alligator cracking • Cracks are 1/2" to 1" some have been previously sealed

Figure 3-9. Yuma Roadway Conditions

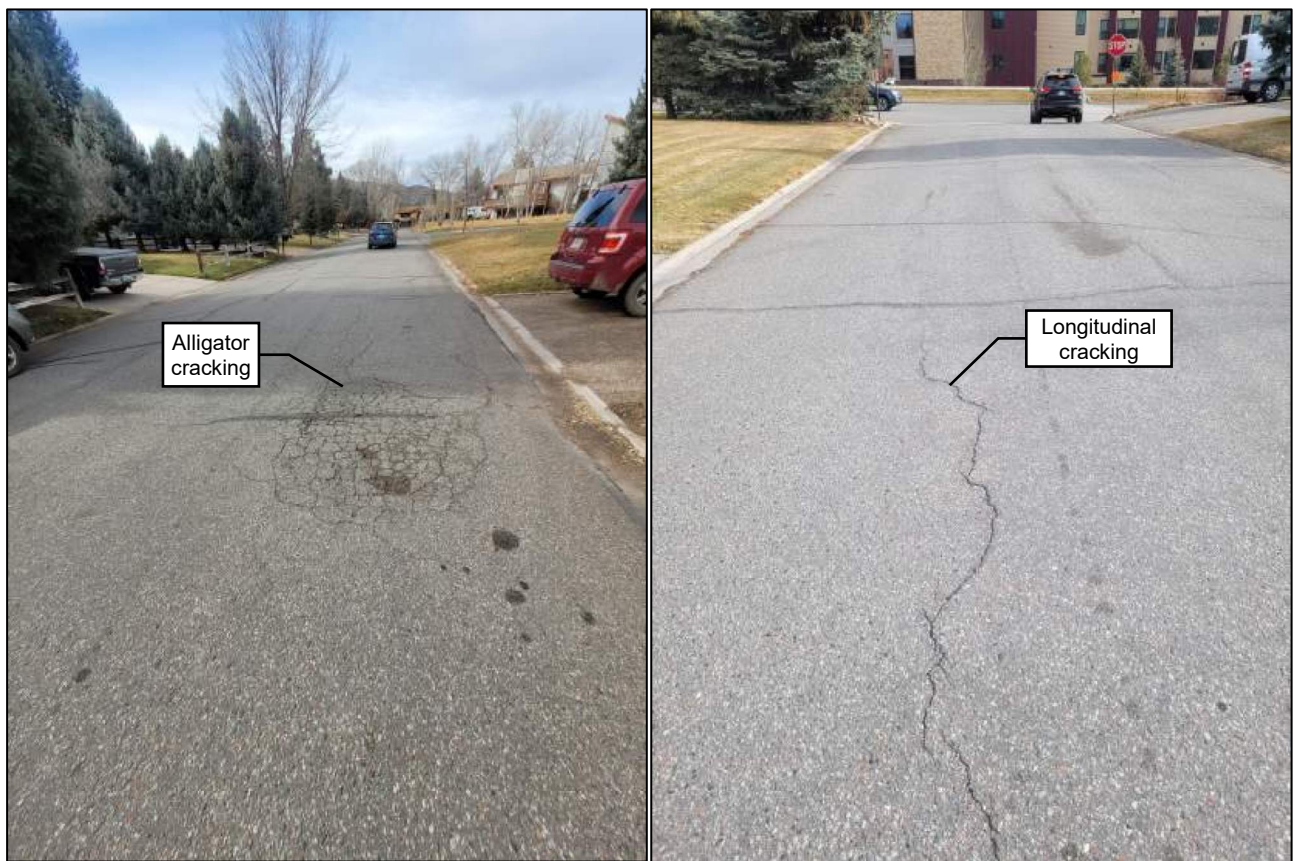
STREET SECTION DESCRIPTION	ASPHALT PASER RATING	MINIMUM RECOMMENDED REMEDY/ ACTION	NOTES
16 Hopi to 112 Hopi	5	Maintain with sealcoat or thin overlay	<ul style="list-style-type: none"> • Blocking 10' to 15' • Moderate polishing sporadic longitudinal cracking • Rutting is low < 1/2" • Unraveling in areas • 3 areas of alligator cracking • Cracks 1/2" to 1" some have been previously sealed
112 Hopi to 234 Hopi	4	Structural overlay > 2"

Figure 3-10. Hopi Roadway Conditions
